MEMORANDUM

Re: Post-TCRA Semi-Annual Inspection Report – October 2015

This document reports the results of the October 2015 inspection of the armored cap cover, fencing, and signage installed for the Time Critical Removal Action (TCRA) at the San Jacinto River Waste Pits Superfund Site (TCRA Site).

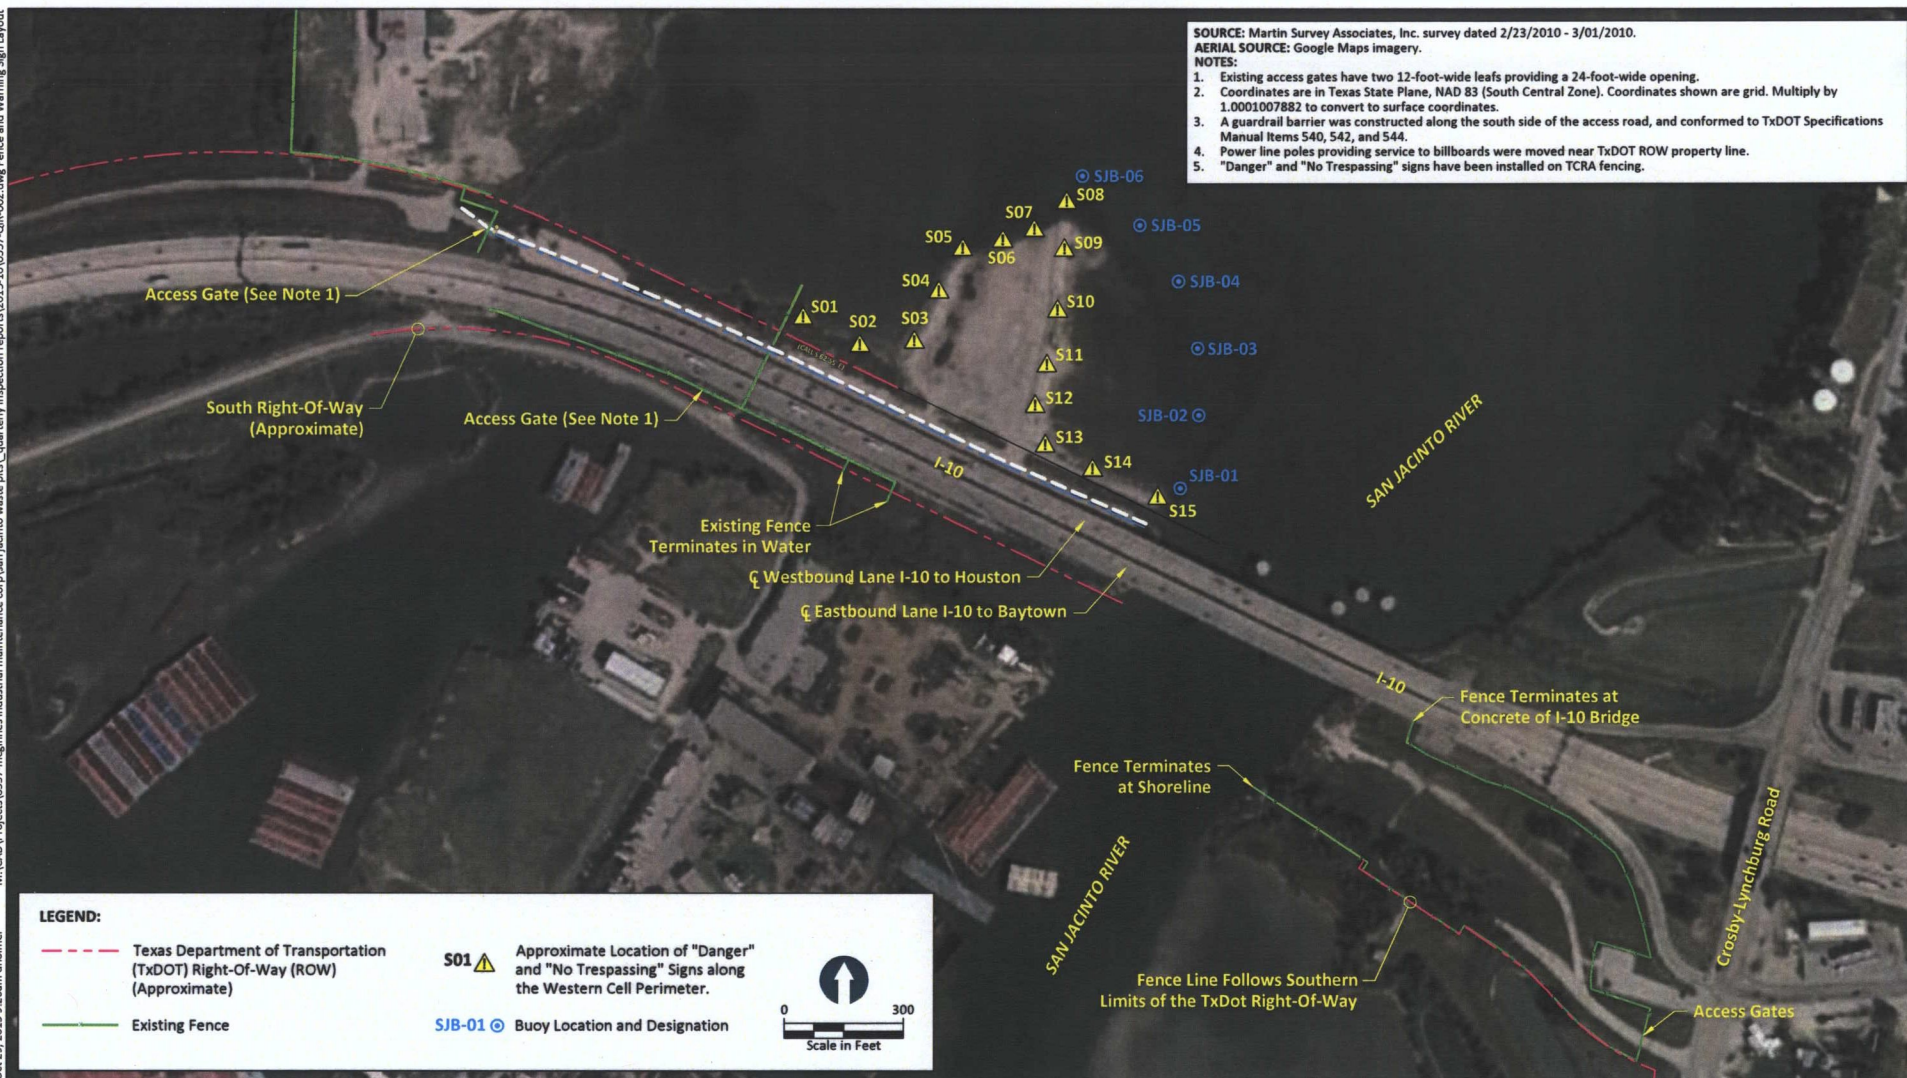
Figure 2
 Fence and Warning Sign Layout
 Post TCRA Semi-Annual Inspection (October 2015)
 San Jacinto River Waste Pits Superfund Site

The perimeter fencing on the west and east banks of the San Jacinto River was visually inspected for breaches or other signs of damage. No breaches or other signs of fence damage were observed during the inspection for any of the three sections of the fence: the east bank, the west bank on the north side of I-10, or the west bank on the south side of I-10. For examples, see Photographs 12 and 14 through 16 in Appendix A.

"Danger" and "No Trespassing" signs are posted at regular intervals on the perimeter fencing surrounding the TCRA Site. For examples, see Photographs 12 and 14 in Appendix A. These signs were observed to be in place during the October 13, 2015 inspection.
